SMOKE TESTING OBSERVATION SUMMARY

Western Run Pilot Project - Baltimore Maryland

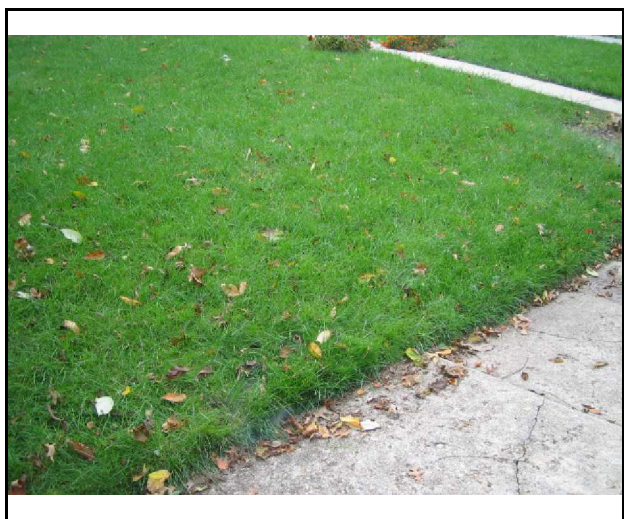
Photo No: 577

Unique Test ID	329	Date:	10/18/2004	MeterBasin:	01_WR06
Observer ID:	B	Crew:	T-2	Dye Test Recommended:	N
Defect No:	2	Setup No:	4	Priority CCTV:

House Number	6302	Street Prefix:		Street Name:	Cross Country	Street Type:	Blvd
Source Type:	02= Service Line	Location:	5=Sidewalk	Severity:	2=Trace		
Sector:	1=Public	Drainage Area:	20				
Comments:

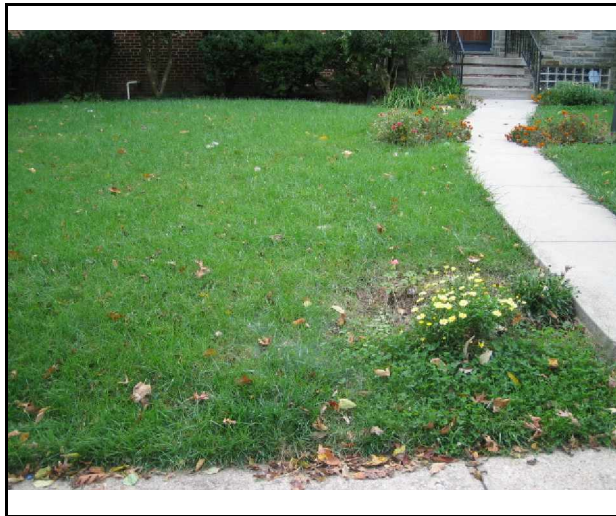
Photo No: 578

Unique Test ID	329	Date:	10/18/2004	MeterBasin:	01_WR06
Observer ID:	B	Crew:	T-2	Dye Test Recommended:	N
Defect No:	3	Setup No:	4	Priority CCTV:

House Number	Street Prefix:	Street Name:	Street Type:
6302		Cross Country	Blvd

Source Type:	02= Service Line	Location:	7=Yard-Front	Severity:	3=Moderate
Sector:	2=Private	Drainage Area:	20

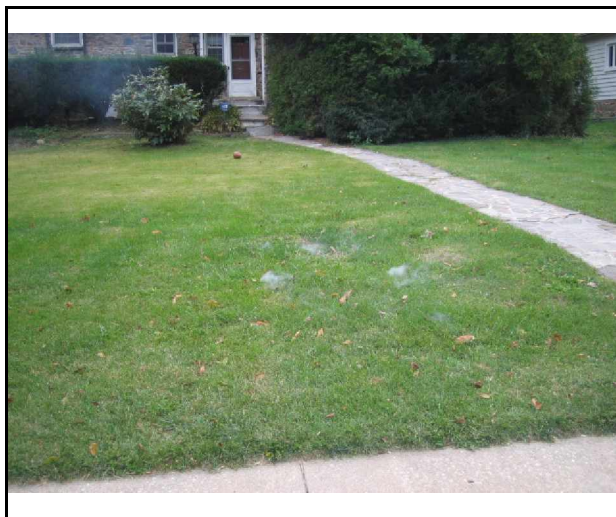
Photo No: 583

Unique Test ID	330	Date:	10/18/2004	MeterBasin:	01_WR05
Observer ID:	B	Crew:	T-2	Dye Test Recommended:	N
Defect No:	10	Setup No:	5	Priority CCTV:

House Number	6204	Street Prefix:		Street Name:	Cross Country	Street Type:	Blvd
Source Type:	02= Service Line	Location:	7=Yard-Front	Severity:	4=Major		
Sector:	2=Private	Drainage Area:	25				
Comments:

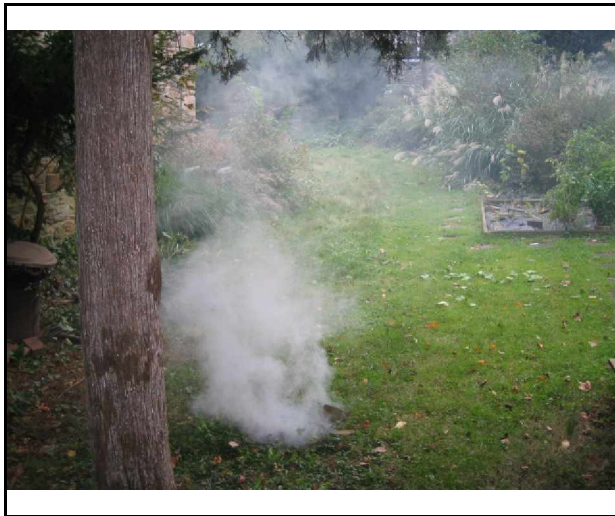
Photo No: 579

Unique Test ID	330	Date:	10/18/2004	MeterBasin:	01_WR06
Observer ID:	B	Crew:	T-2	Dye Test Recommended:	N
Defect No:	2	Setup No:	5	Priority CCTV:

House Number	Street Prefix:	Street Name:	Street Type:		
3107		W Strathmore	AVE		
Source Type:	02= Service Line	Location:	8=Yard-Back	Severity:	4=Major
Sector:	2=Private	Drainage Area:	200		
Comments:

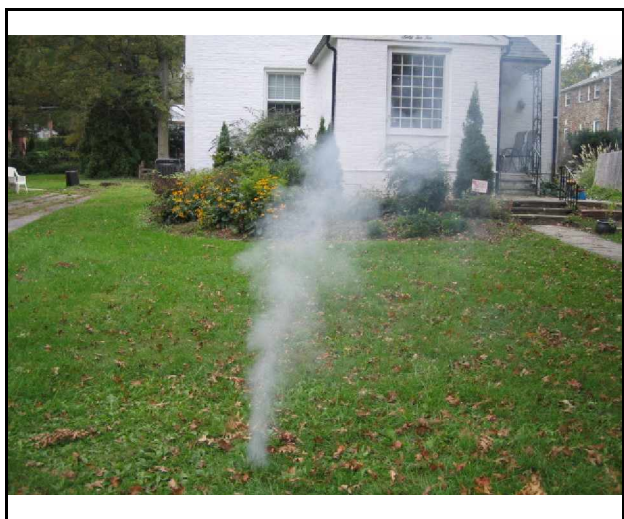
Photo No: 580

Unique Test ID	330	Date:	10/18/2004	MeterBasin:	01_WR05
Observer ID:	B	Crew:	T-2	Dye Test Recommended:	N
Defect No:	4	Setup No:	5	Priority CCTV:

House Number	6210	Street Prefix:		Street Name:	Cross Country	Street Type:	Blvd
Source Type:	04= Cleanout	Location:	7=Yard-Front	Severity:	4=Major		
Sector:	2=Private	Drainage Area:	16				
Comments:

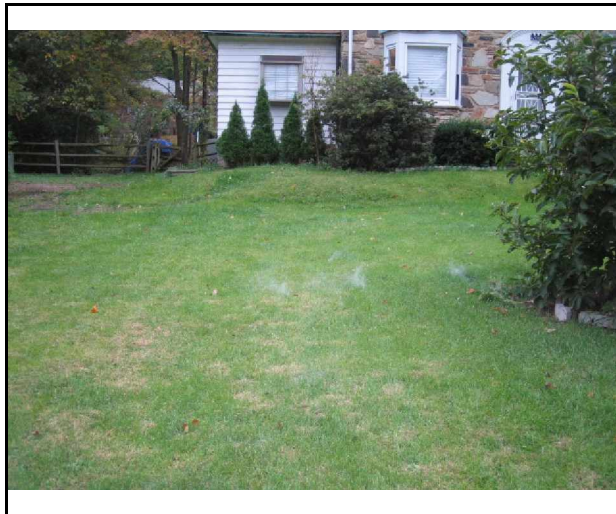
Photo No: 581

Unique Test ID	330	Date:	10/18/2004	MeterBasin:	01_WR05
Observer ID:	B	Crew:	T-2	Dye Test Recommended:	N
Defect No:	7	Setup No:	5	Priority CCTV:

House Number	Street Prefix:	Street Name:	Street Type:		
6206		Cross Country	Blvd		
Source Type:	02= Service Line	Location:	7=Yard-Front	Severity:	3=Moderate
Sector:	2=Private	Drainage Area:	100		
Comments:

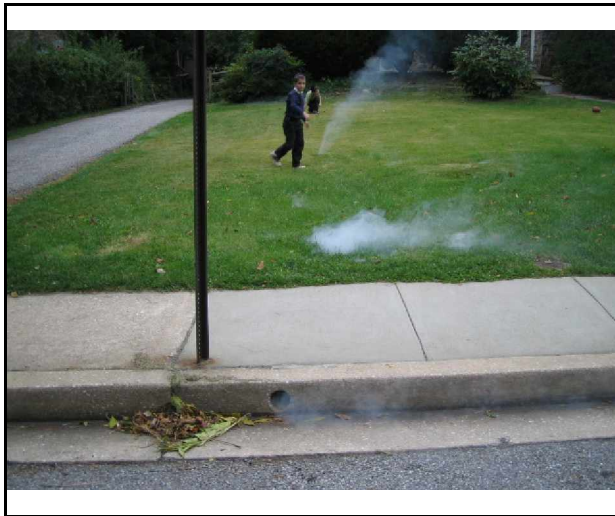
Unique Test ID	330	Date:	10/18/2004	MeterBasin:	01_WR05
Observer ID:	B	Crew:	T-2	Dye Test Recommended:	N
Defect No:	9	Setup No:	5	Priority CCTV:

House Number	Street Prefix:	Street Name:	Street Type:		
6204		Cross Country	Blvd		
Source Type:	02= Service Line	Location:	5=Sidewalk	Severity:	4=Major
Sector:	1=Public	Drainage Area:	120		
Comments:

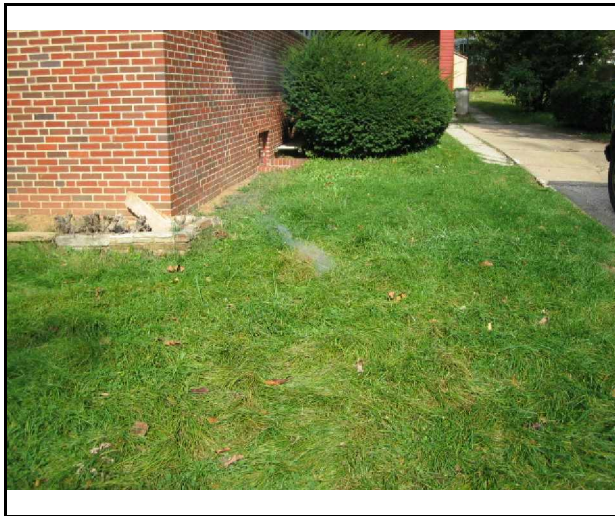
Unique Test ID	331	Date:	10/18/2004	MeterBasin:	01_WR29
Observer ID:	A	Crew:	T-3	Dye Test Recommended:	N
Defect No:	2	Setup No:	1	Priority CCTV:

House Number	7009	Street Prefix:		Street Name:	Wallis	Street Type:	AVE
Source Type:	04= Cleanout	Location:	7=Yard-Front	Severity:	4=Major		
Sector:	2=Private	Drainage Area:	5				
Comments:

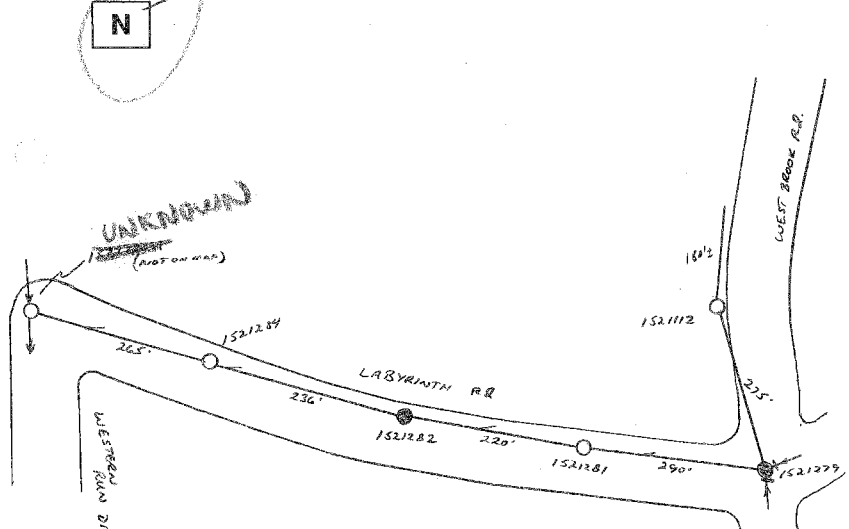
THIS LINE DROPS INTO A NEWER LINE ON WESTERN RUN DR. THATS NOT ON THE MAP

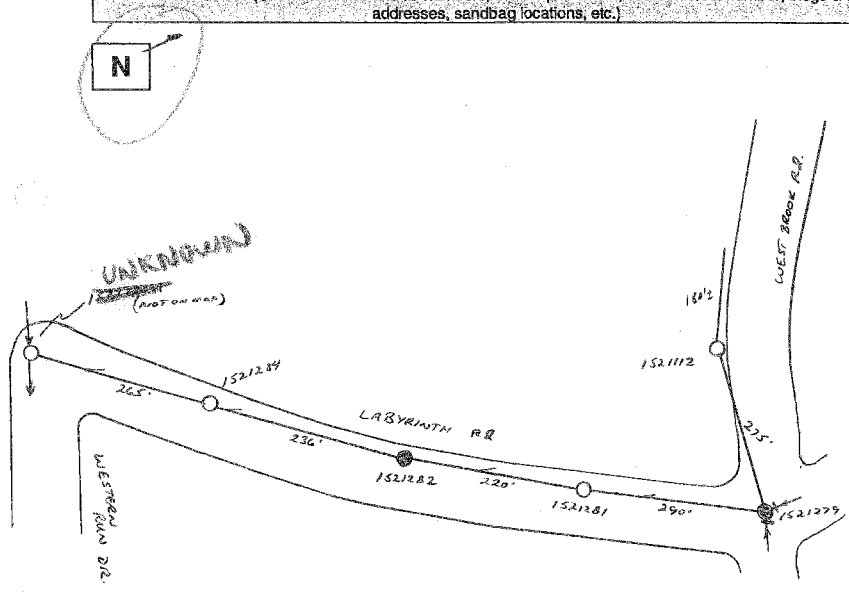
THIS LINE DROPS INTO A NEWER LINE ON WESTERN RUN DR. THATS
NOT ON THE MAP

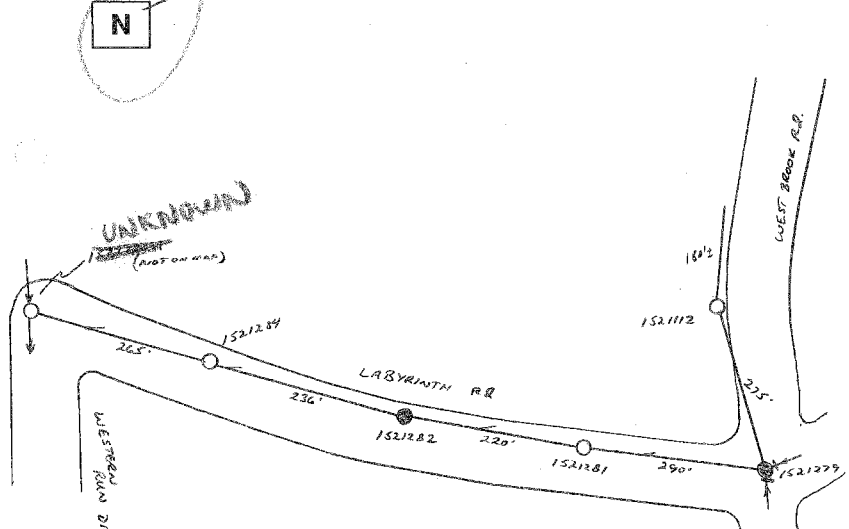
THIS LINE DROPS INTO A NEWER LINE ON WESTERN RUN DR. THATS NOT ON THE MAP
